# **Debris/Ice/TPS Assessment and Integrated Photographic Analysis of Shuttle Mission STS-84**

**DEBRIS/ICE/TPS ASSESSMENT  
AND  
INTEGRATED PHOTOGRAPHIC ANALYSIS  
OF  
SHUTTLE MISSION STS-84**

**15 May 1997**

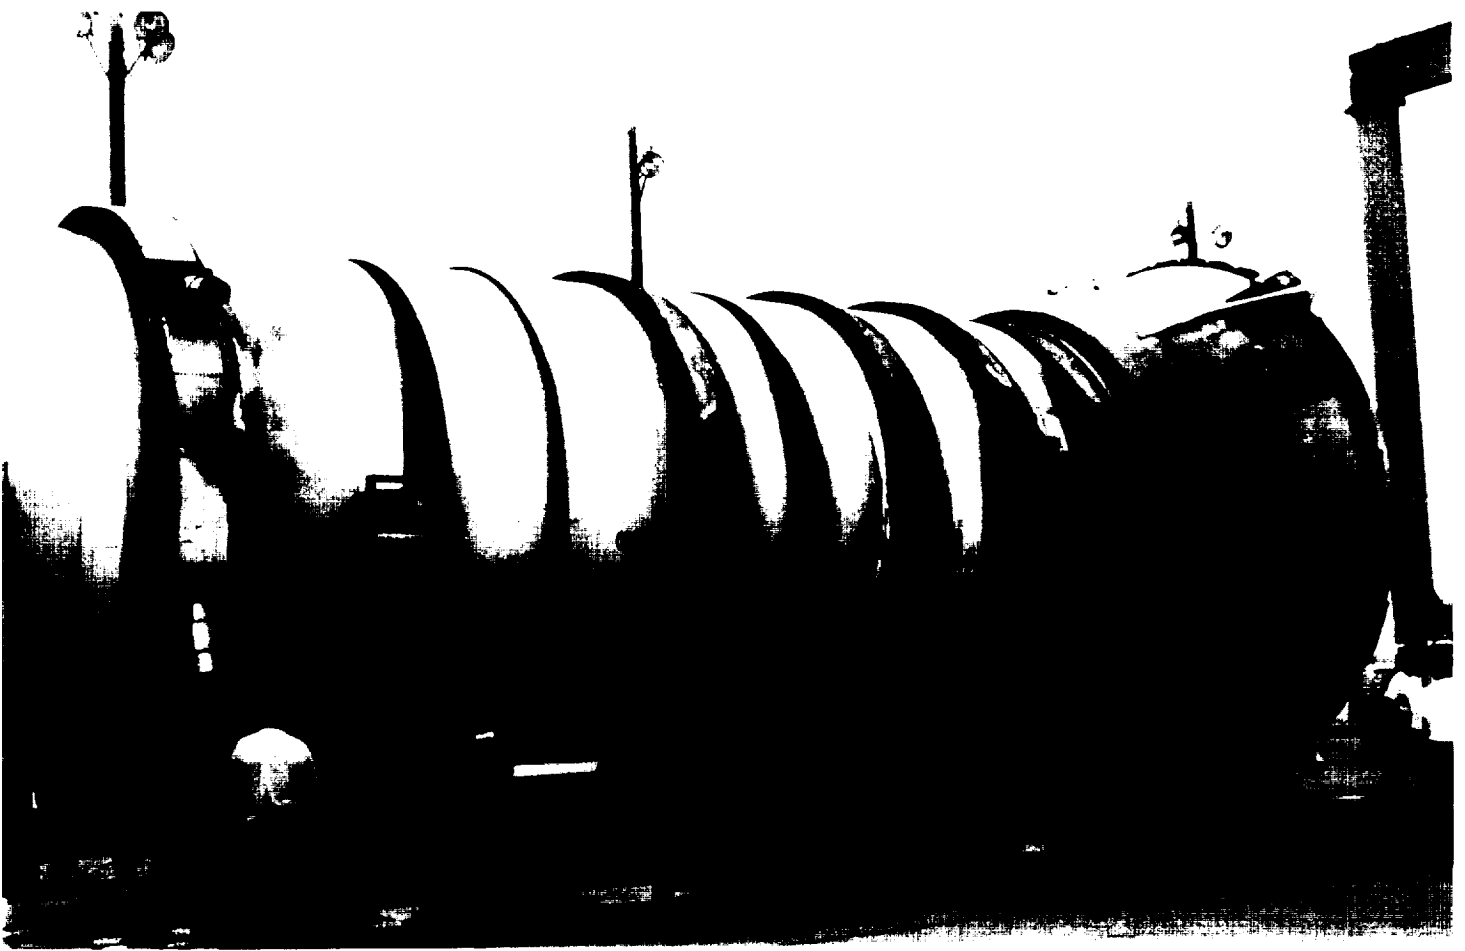
**Photo 12: Left and Right Aft Boosters**

TPS on the external surface of both aft skirts was intact and in good condition. Internally, less than usual amounts of foam were missing on the aft skirt aft rings.

Six of the holddown post Debris Containment Systems (DCS) plungers were seated and appeared to have functioned normally. The HDP #1 DCS plunger was obstructed by frangible nut halves. The HDP #7 plunger was not fully seated, but partially obstructed by a piece of the frangible nut.

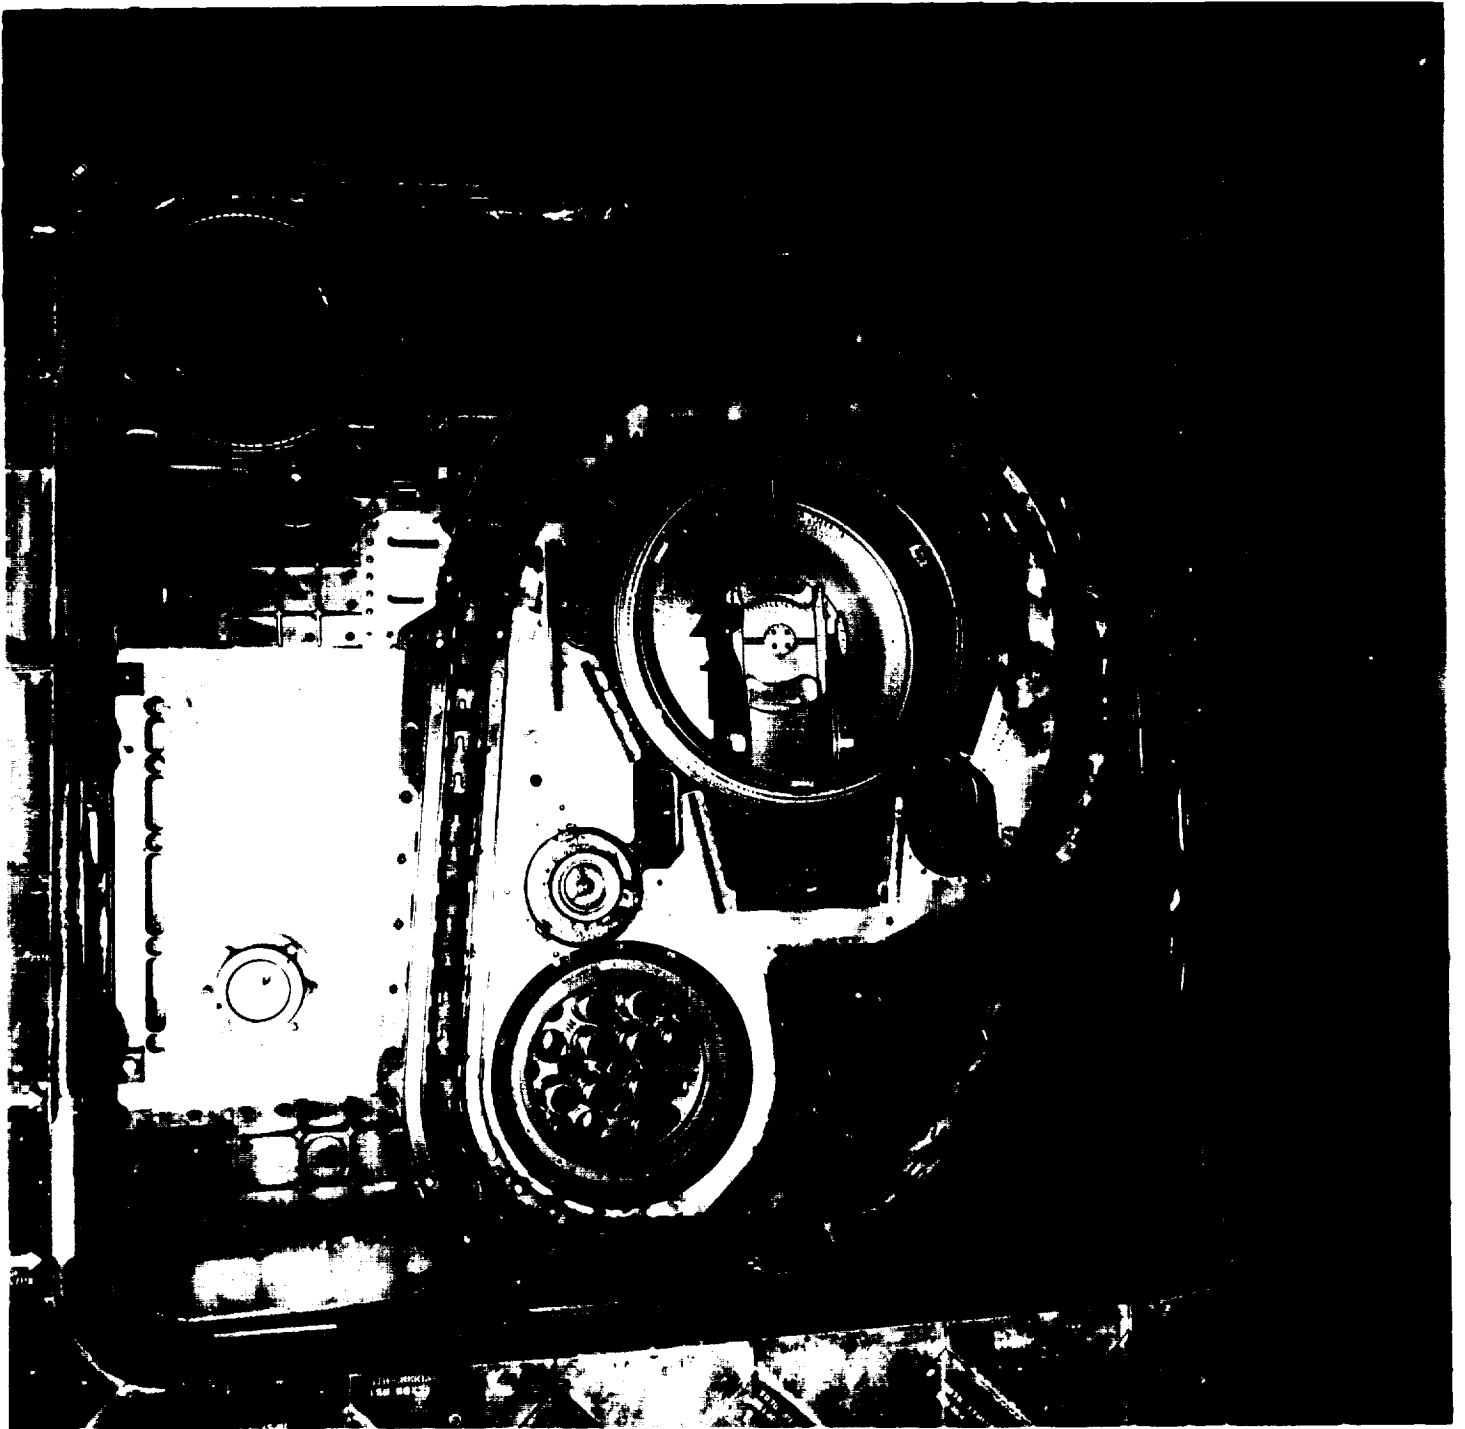
**Photo 19: LO2 ET/ORB Umbilical**

Tile damage sites aft of the LH2 and LO2 ET/ORB umbilicals were typical in size and quantity. The damage was most likely caused by impacts from umbilical ice or shredded pieces of umbilical purge barrier material flapping in the airstream, both of which were observed in launch films.

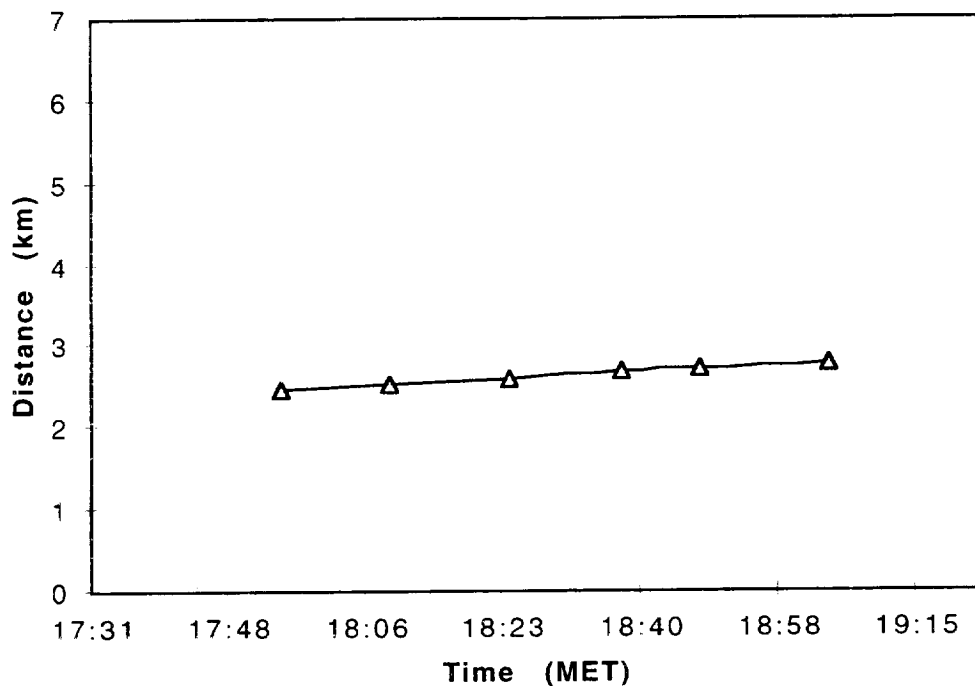
Figure 2.5.2 ET Separation Velocity

The distance of the external tank was calculated on six frames. On the first usable view, the external tank was calculated to be a distance of 2.4 kilometers away from the Orbiter at 17:55 MET. On the last view, the tank was calculated to be at a distance of 2.7 kilometers (1 minute, nine seconds after the first view). The tank separation average velocity was determined to be 4.8 meters/second (m/s), with an uncertainty of approximately 1 m/s. The tank tumble rate was approximately 0.5 degrees/second. The tank roll rate was too small to be determined.

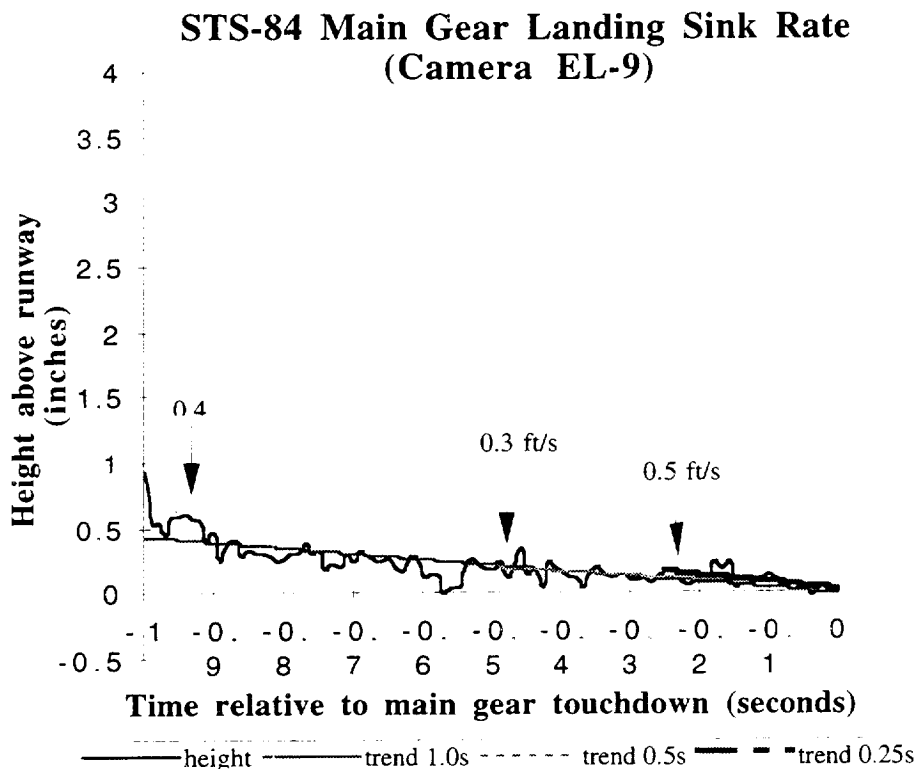
Figure 2.6.1 (A) Main Gear Height versus Time Prior to Touchdown

The measured main gear sink rate values were found to be below the maximum allowable values of 9.6 ft/sec for a 211,000 lb. vehicle and 6.0 ft/sec for a 240,000 lb. vehicle (the landing weight of the STS-84 Orbiter was reported to be 216,167 lb.). The sink rate measurements for STS-84 are given in Table 2.6.1. In Figure 2.6.1(A), and 2.6.1(B), the trend of the measured data points for the image data is illustrated.
